Concrete Scanning, Ground Penetrating Radar, 3D Imaging & Power Cable Detection

Scan Man Pty Ltd.

Sample Report Showing :- 1. - Concrete Grid Scan Image, 2. - Power Cable Detection, 3. – 3D Imaging.

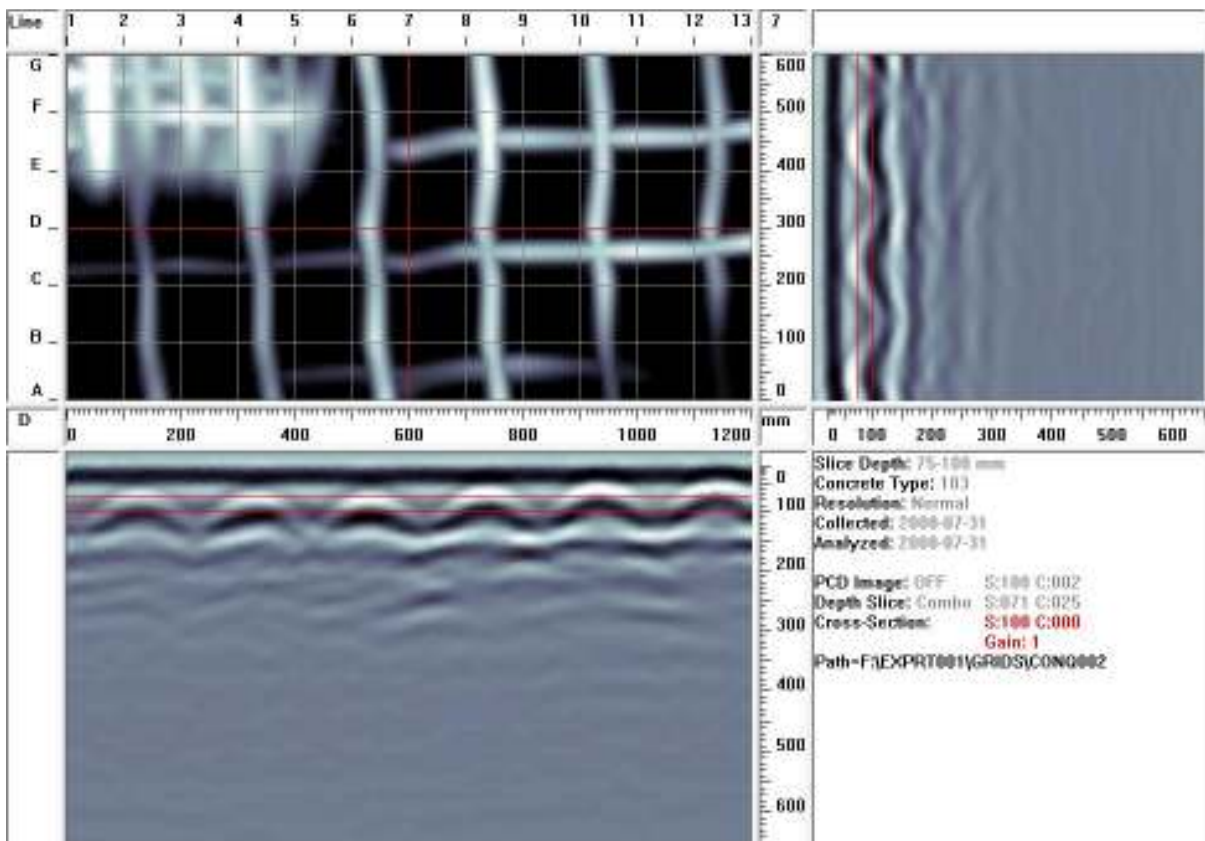
1. The above image shows the ability of Scan Man's latest computer Scanning technology. The quality of image seen gives clear indication of Rebar located at a depth of 100mm (see top right for depth). This scan also shows a dense mass in the top left, in this case showing a Telstra Service Pit.

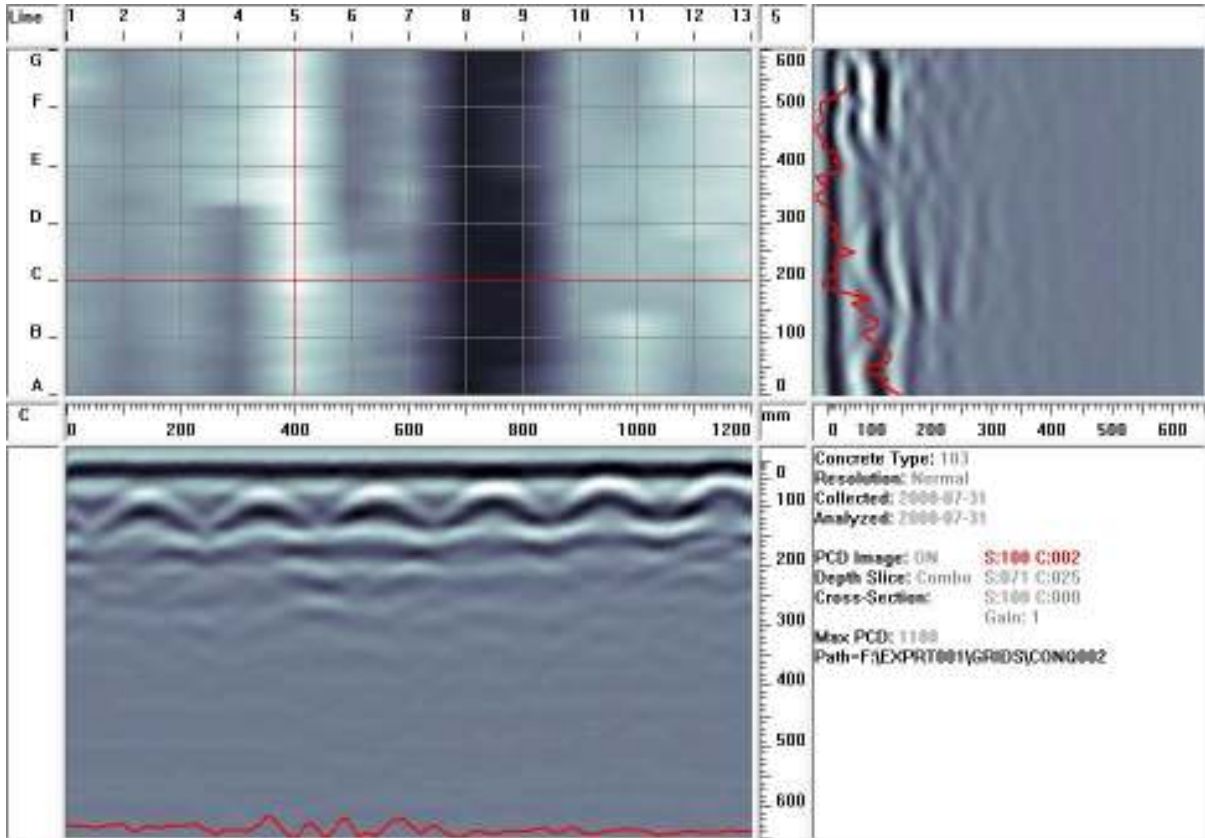
- Below, Scan Man's Power Cable Detection technology shows a slice view of the above image with red cross hairs (top left) indicating views of associated images.

Vertical red line = Top Right Image. Image shows power (Red Line Indicator) at a depth of 150mm moving up towards the rear of the scanned area.

Horizontal red line= Bottom Image. Slice view with power indicated with fluctuated line at 350mm – 650mm mark.
